MOHAWK RIVER BASIN  
CITY OF GLOVERSVILLE  
FULTON COUNTY, NEW YORK

# WEST MILLPOND DAM

## NY 01060

PHASE I INSPECTION REPORT  
NATIONAL DAM INSPECTION PROGRAM

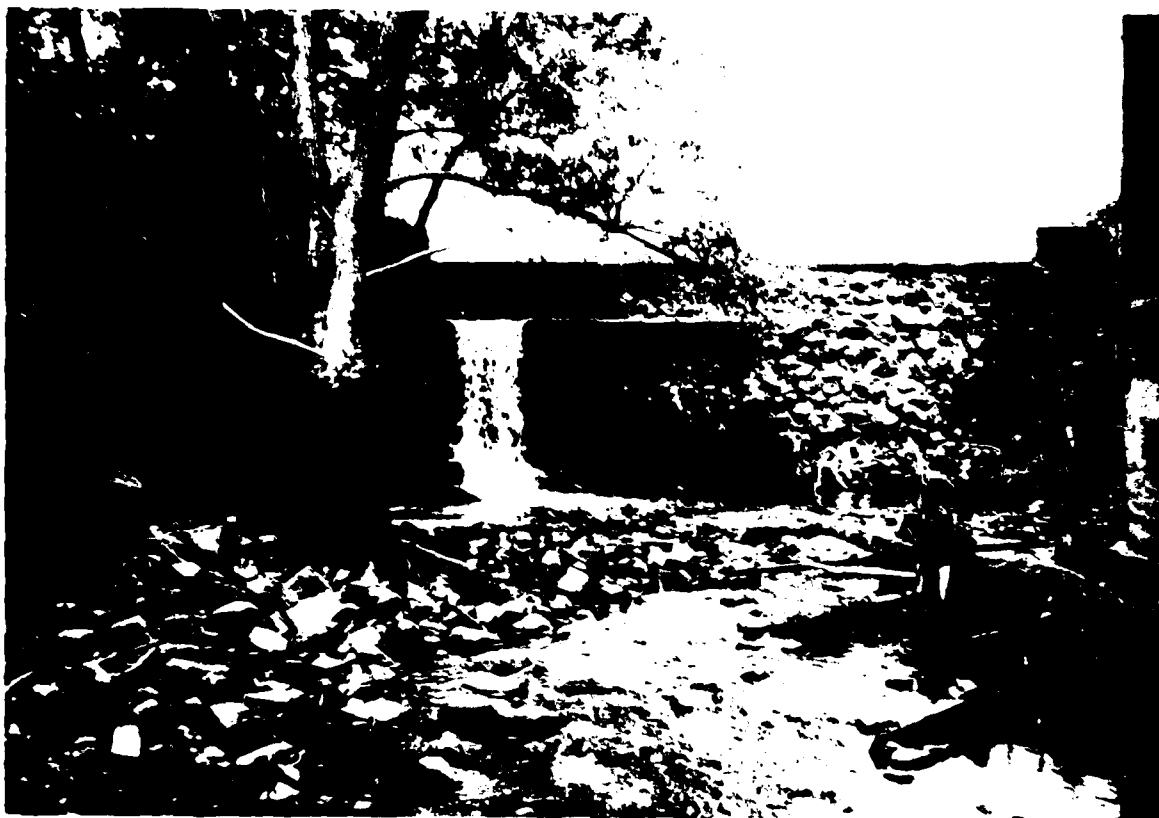
Overview Photo - West Millpond Dam ( spillway ) - 6 3 81

Zone Next to Downstream Toe - Several large trees are growing in the zone next to the downstream toe of the embankment to the right of the spillway. There is a mill building at the downstream toe of the embankment to the left of the spillway. The stone masonry at the toe of the dam, below the end of spillway, is in good condition (see Photo A-8A and Overview Photo).

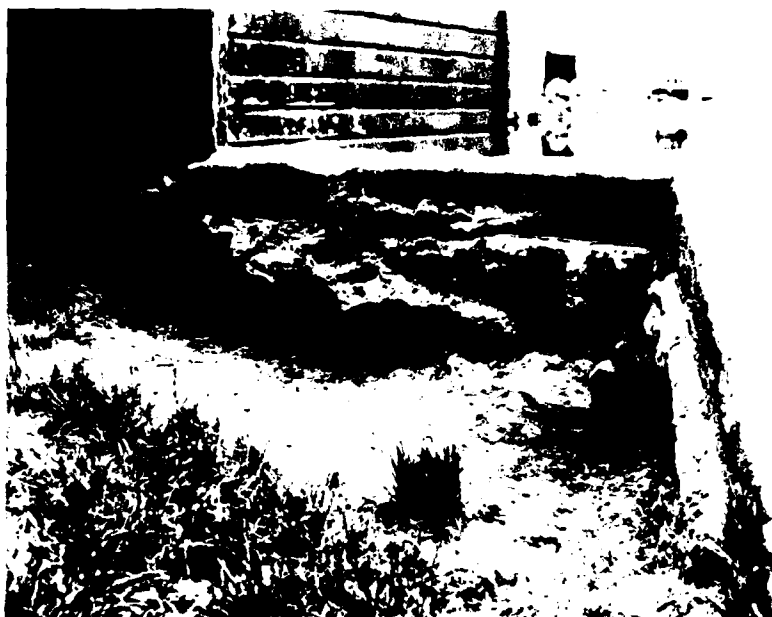
A-3A Apparent erosion or lost ground on downstream side of upstream retaining wall next to right side of spillway - 6/3/81
